Structural use of glass: Cruciform columns and glass portals with bolted connections subjected to bending

Rasmus Ingomar Petersen, Anne Bagger
Ramboll Denmark, Teknikerbyen 31, DK-2830 Virum, Denmark

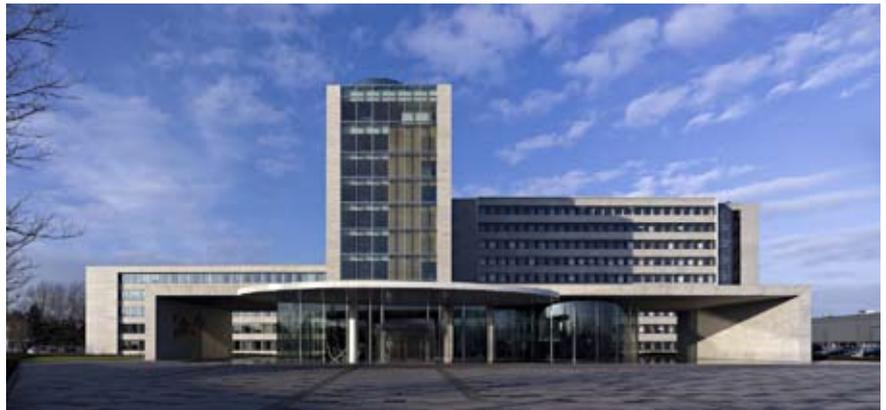
Figure 1
Front view of the new reception building

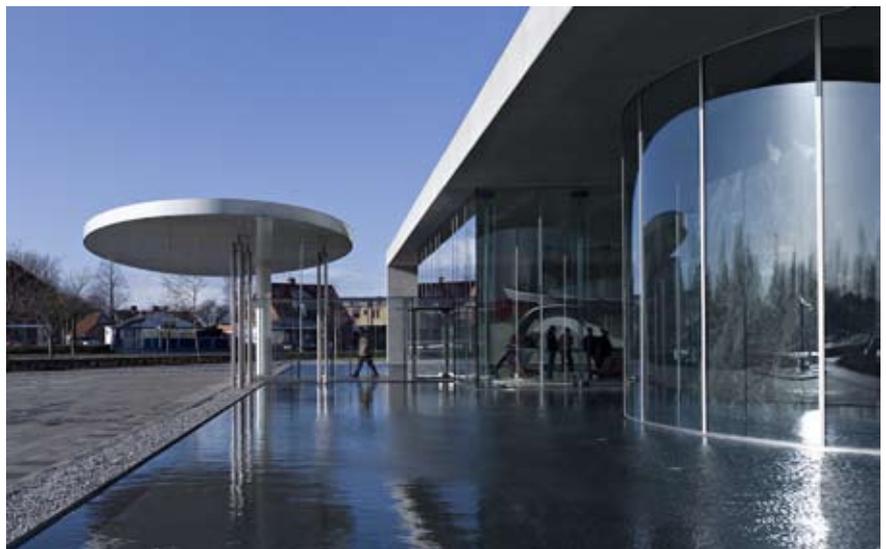
Figure 2
Side view of the new reception building with the glazed entranceway

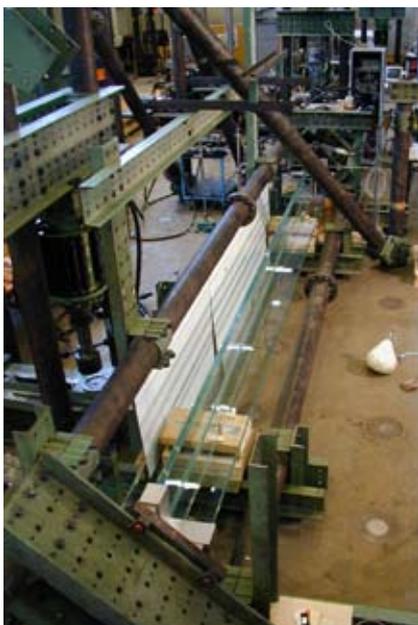
Figure 5
Test set-up for full-scale testing of the glass column

The column was laid horizontally (supported at 1/5 points) and subjected to the following test regime:

Loading to full ultimate limit state axial load of 250 kN for 1 hour with subsequent unloading and checking of the neoprene strips in the steel shoes at both the column's ends.

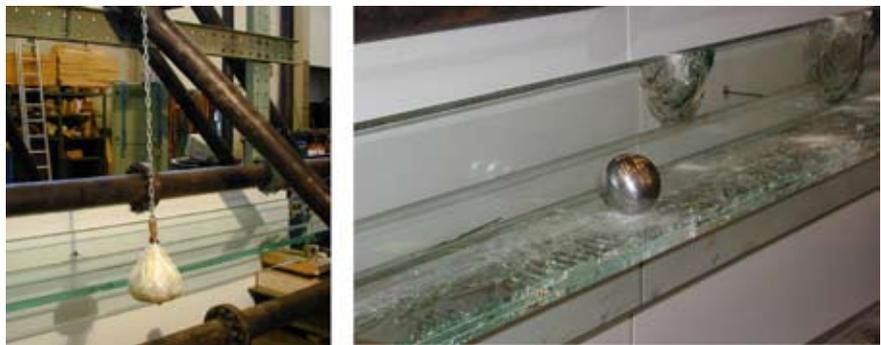
Figure 6
Soft and hard impact testing of the glass column

The column was then subjected to soft and hard impact of the kind used for the testing of safety glass while the column was subjected to the serviceability limit state axial load of 190 kN.

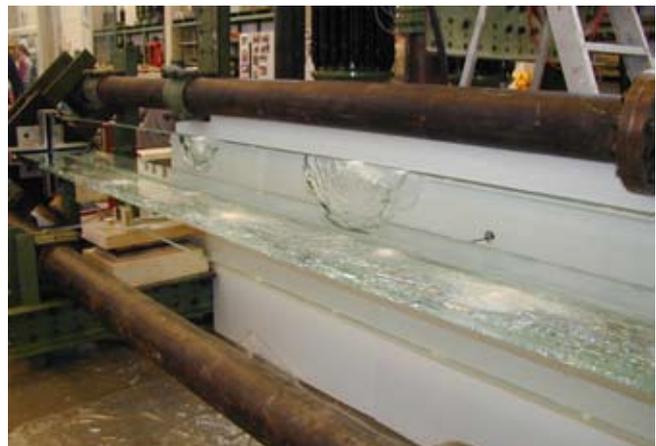
Figure 7
Column after final up-loading and loss of load bearing capacity

Finally the column, with several of the arms heavily damaged from the hard impact testing, was loaded until the column lost its load bearing capacity. This was reached at an axial load of 575 kN. Loss of load bearing capacity was quite un-dramatic without harmful disintegration of the column.

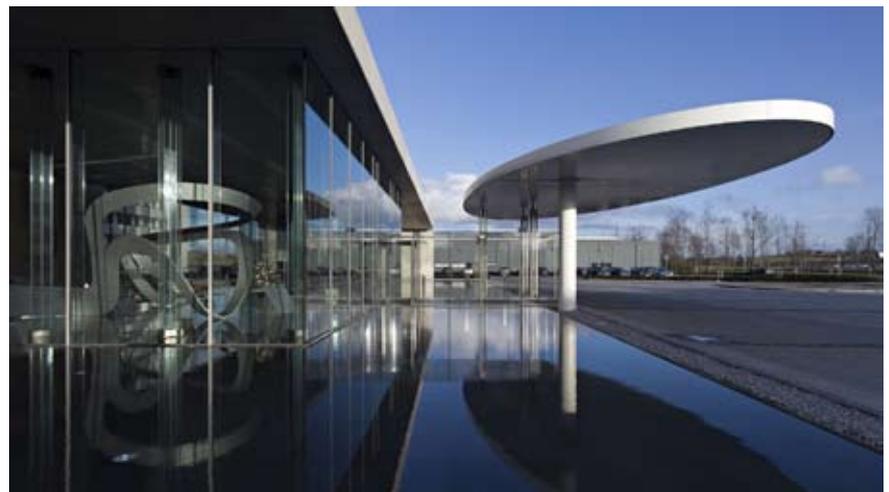
Figure 9
The fully glazed entranceway leading to the reception building's revolving doors

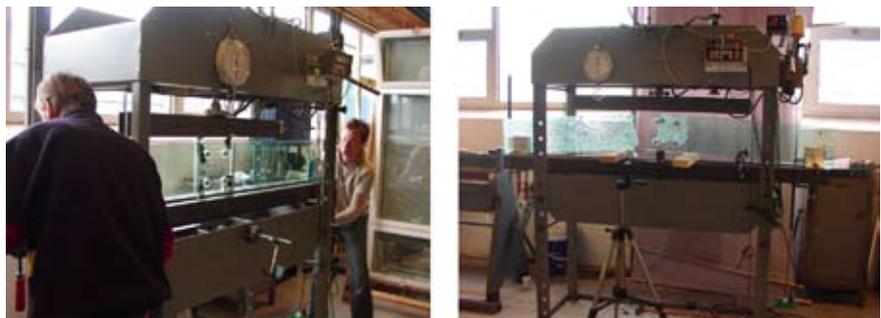
Figure 14
Test rig with test a specimen before and after breakage.

The test results confirmed the confidence in the design even though

2 tests are insufficient as a basis for a statistical evaluation of the strength of the connection.

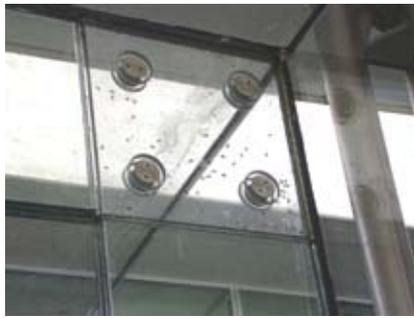
Figure 16

Flies caught in the gaps in the lap joints

insects tend to get stuck in the small space between the glass plates in the entranceway's lap joints.
